INTERSTATE 64 / HIGH RISE BRIDGE CORRIDOR STUDY

CITY OF CHESAPEAKE, VA | STATE PROJECT #: 0064-131-783 | UPC: 104366

NATURAL RESOURCES TECHNICAL REPORT

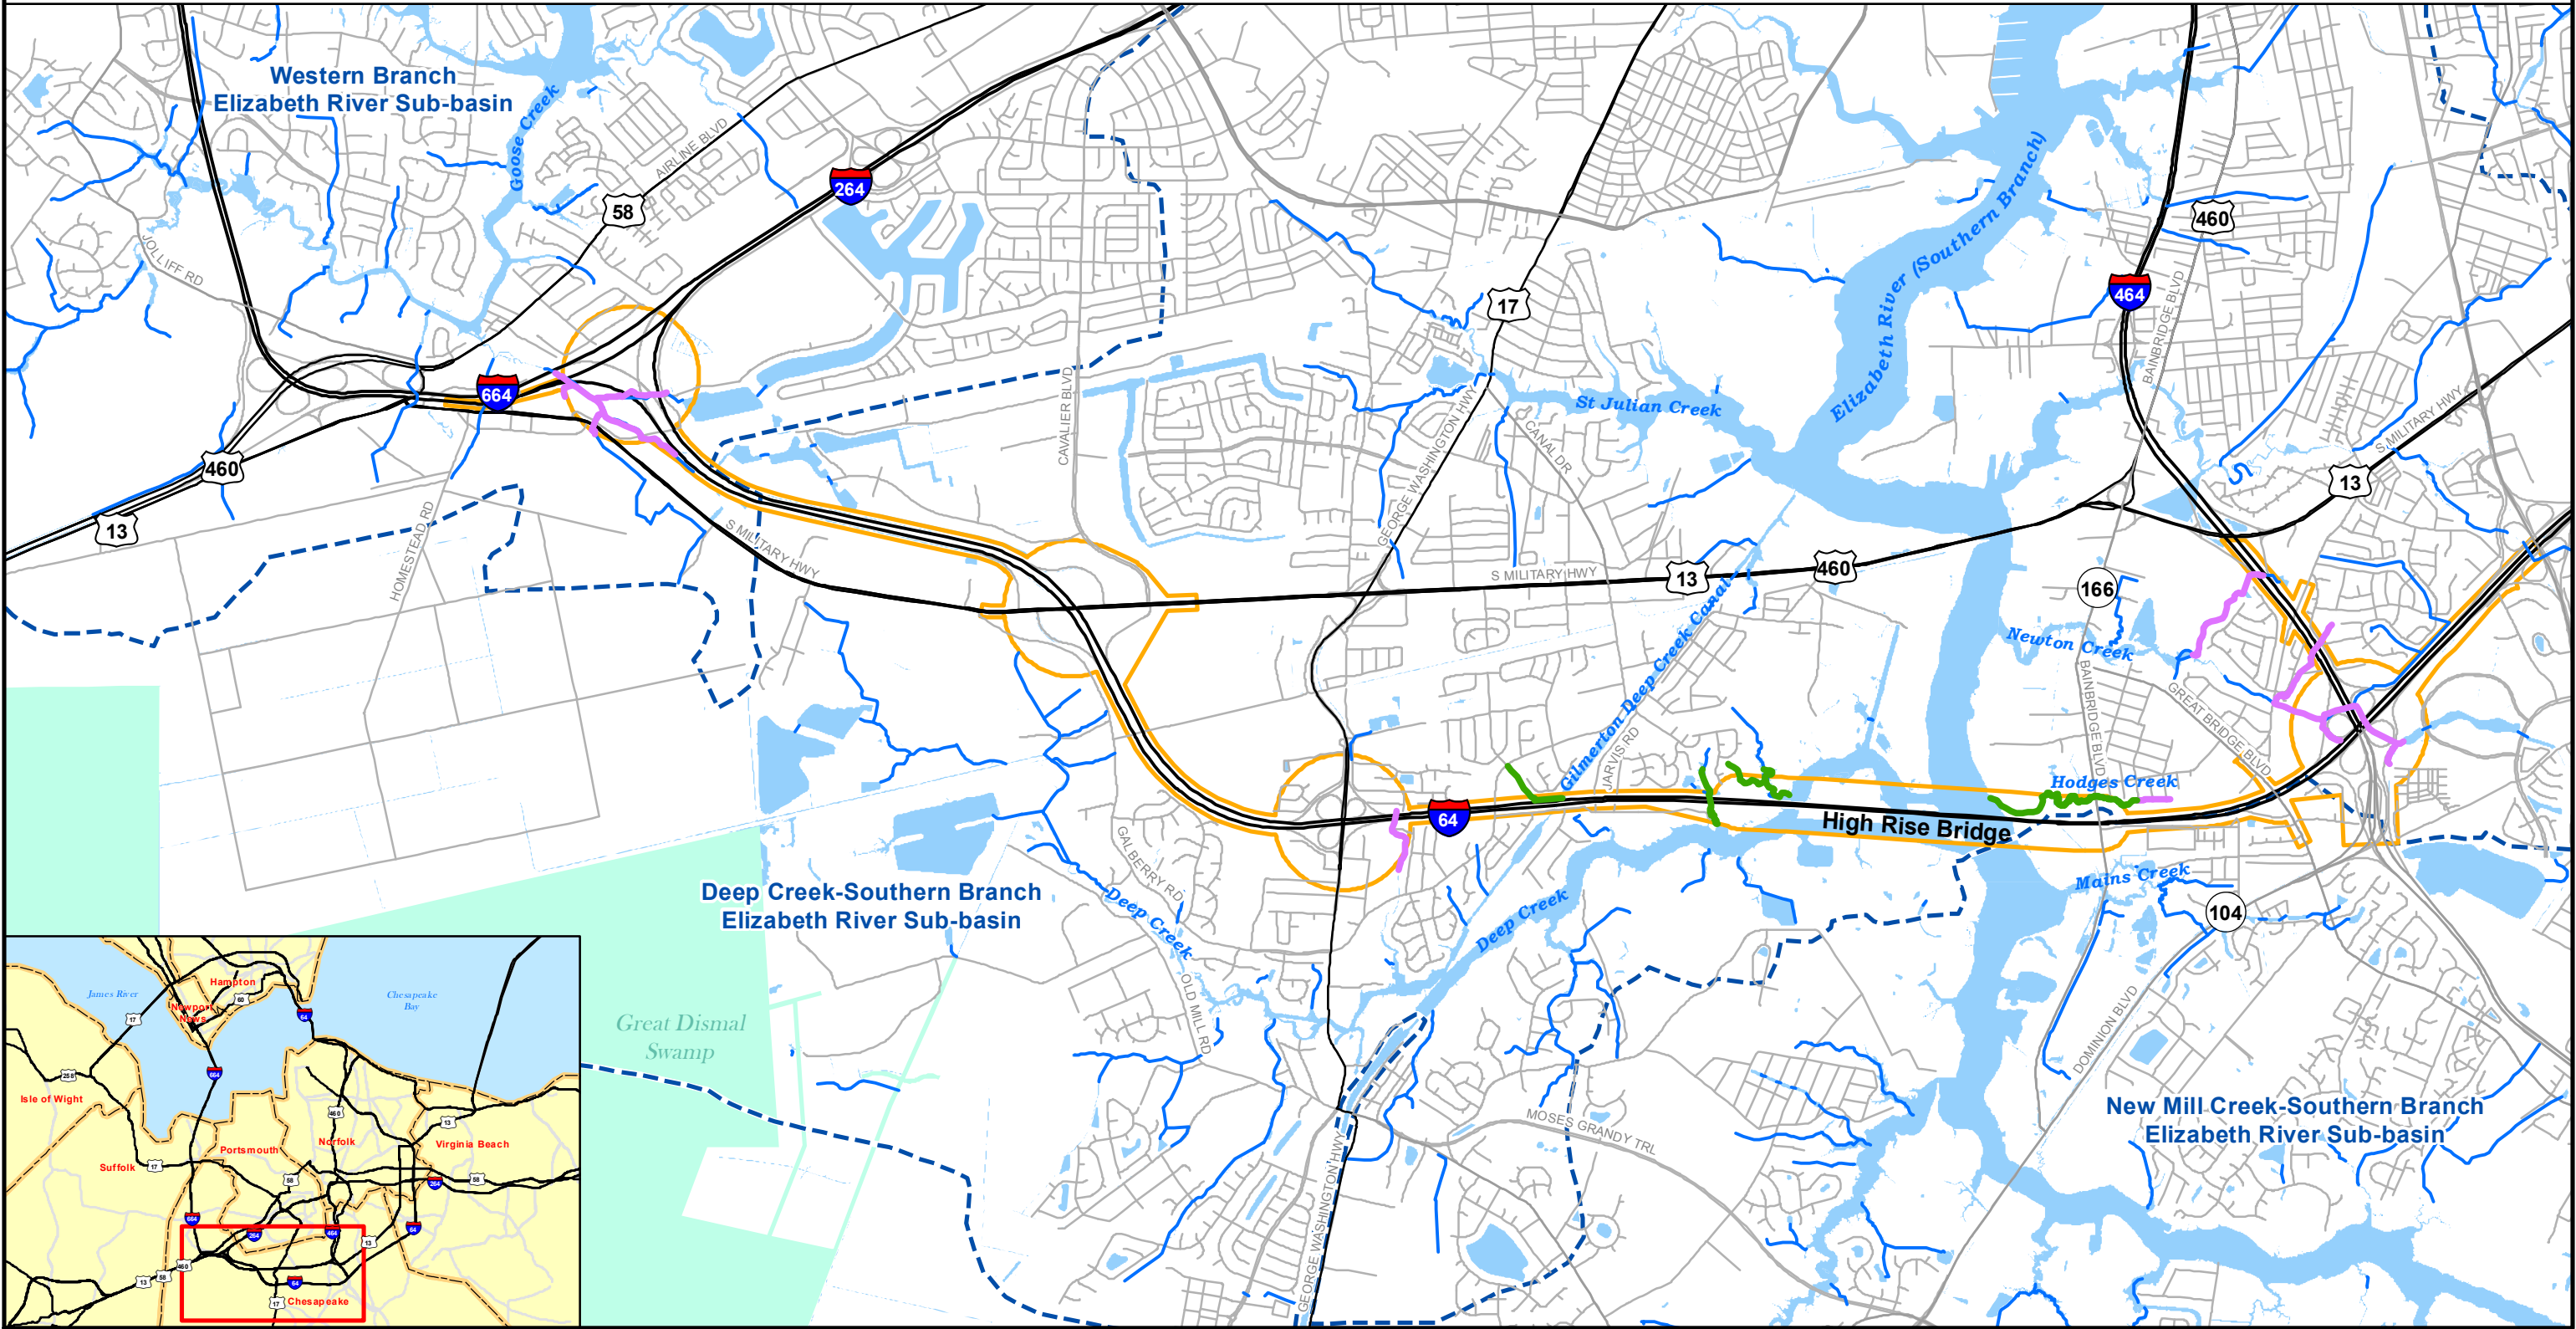
- I 64/High Rise Bridge Corridor Study Area*
- Water Bodies
- Great Dismal Swamp

- Wetlands in Study Area**
- E2EM, 42.54 acres
 - PEM, 4.75 acres
 - PFO, 44.07 acres

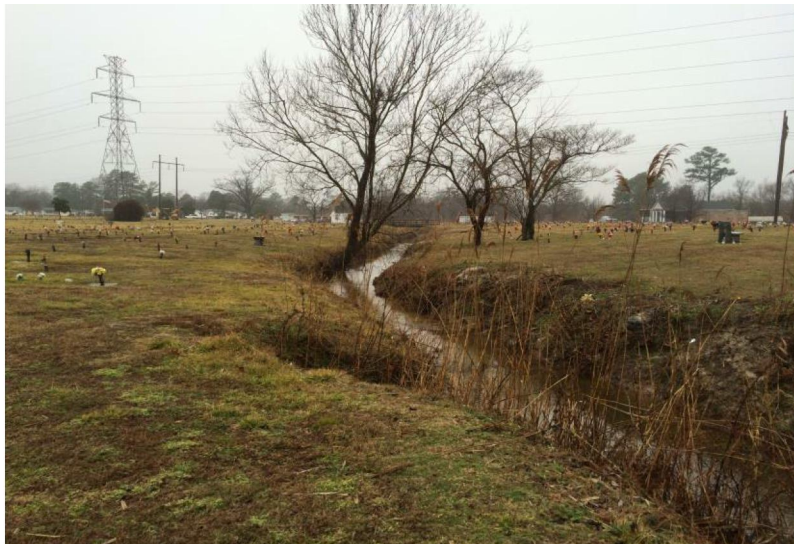
Photo of SAR 1 looking downstream.

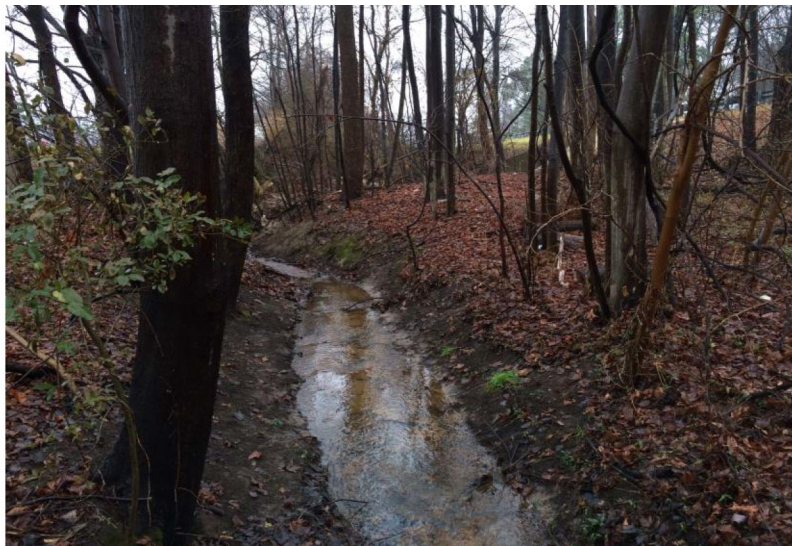
Photo of SAR 2 looking downstream.

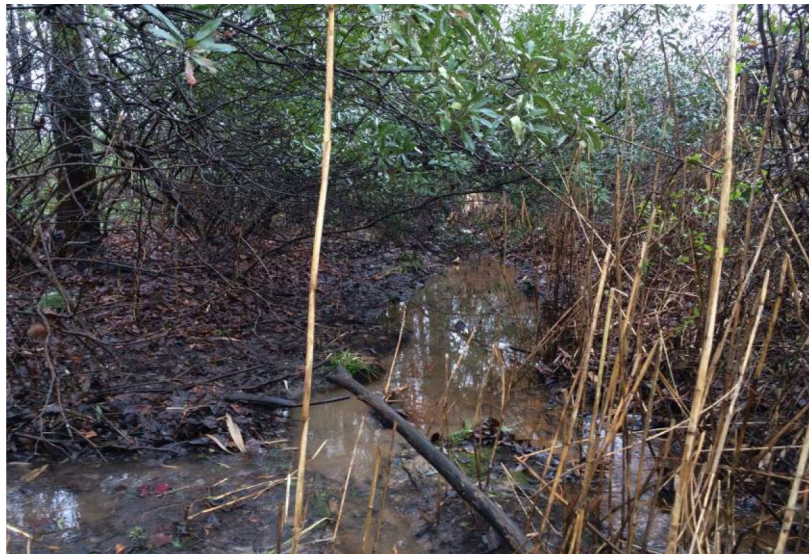
Photo of SAR 3 looking downstream.

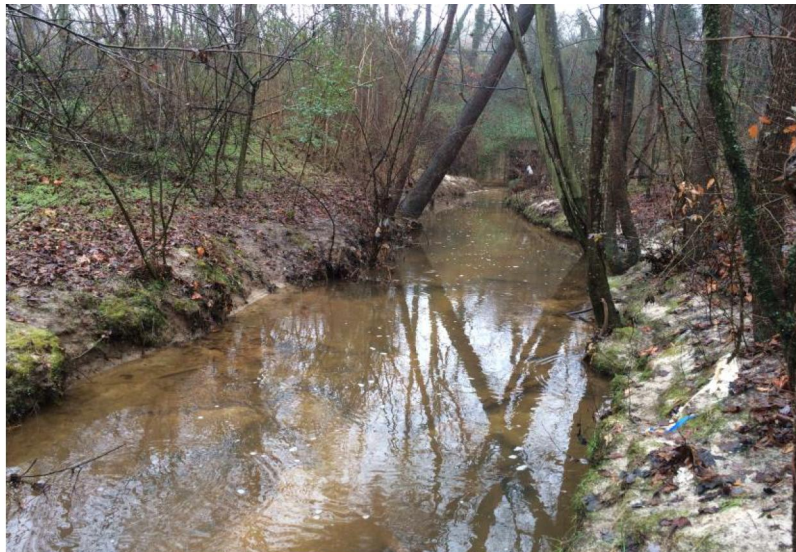
Photo of SAR 4 looking upstream.

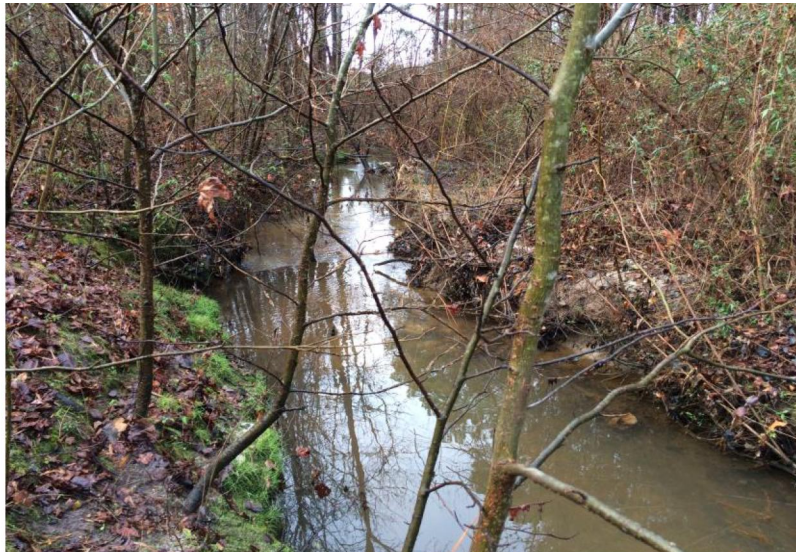
Photo of SAR 5 looking downstream.

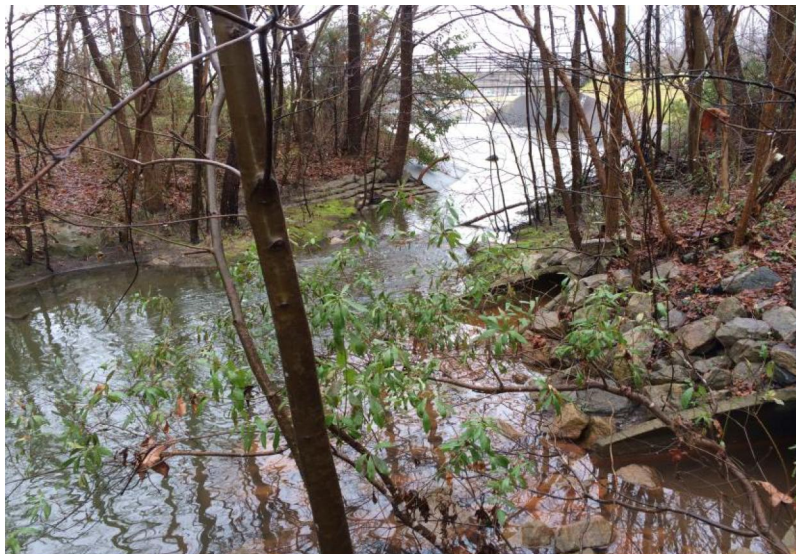
Photo of SAR 6 looking upstream.

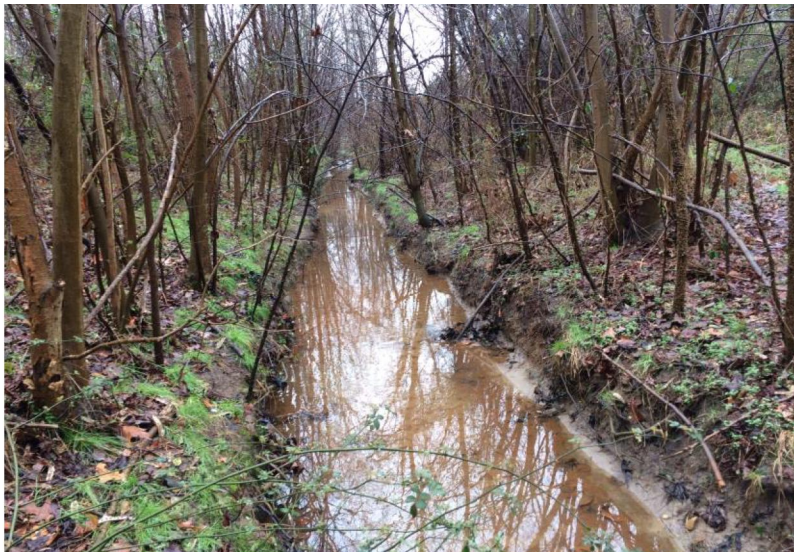
Photo of SAR 7 looking upstream.

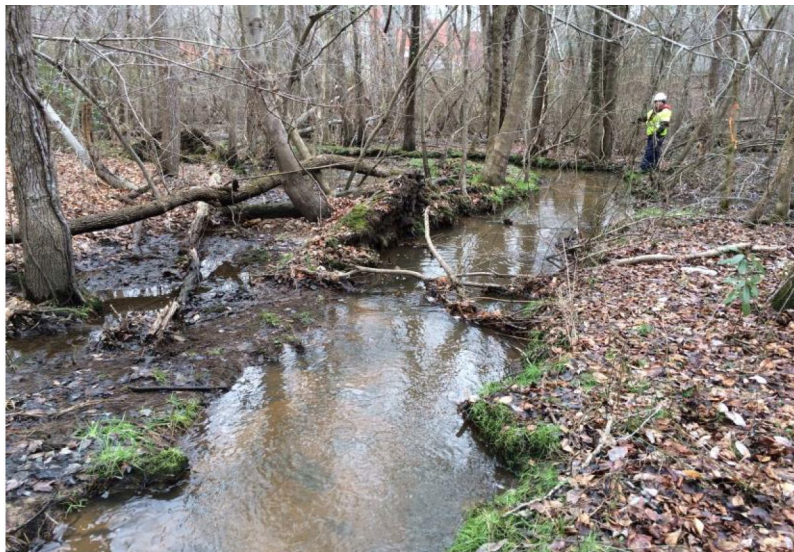
Photo of SAR 8 looking downstream.

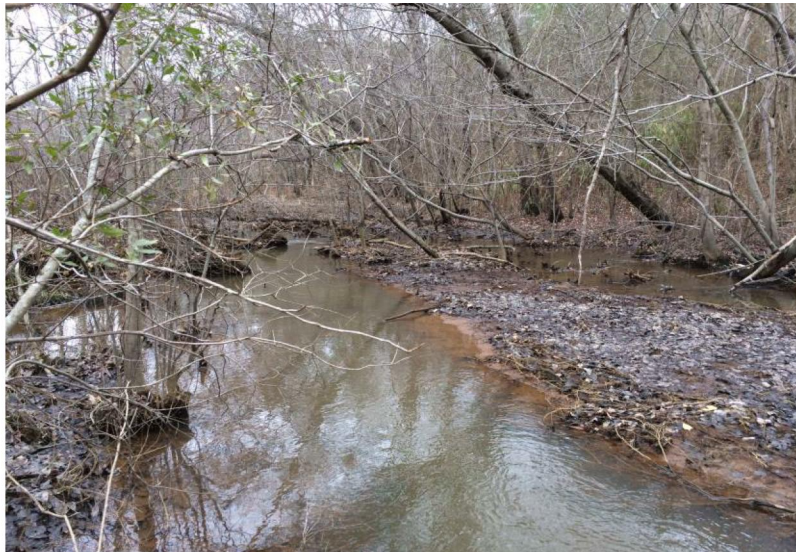
Photo of SAR 9 looking downstream.

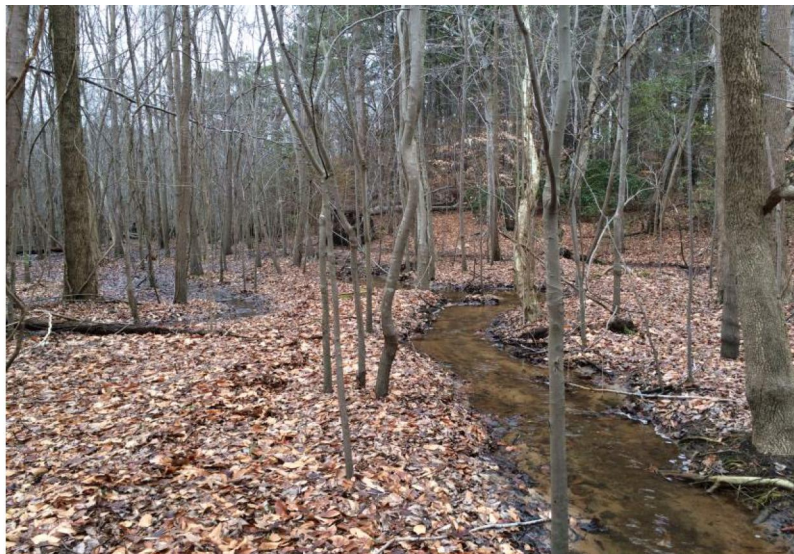
Photo of SAR 10 looking downstream.

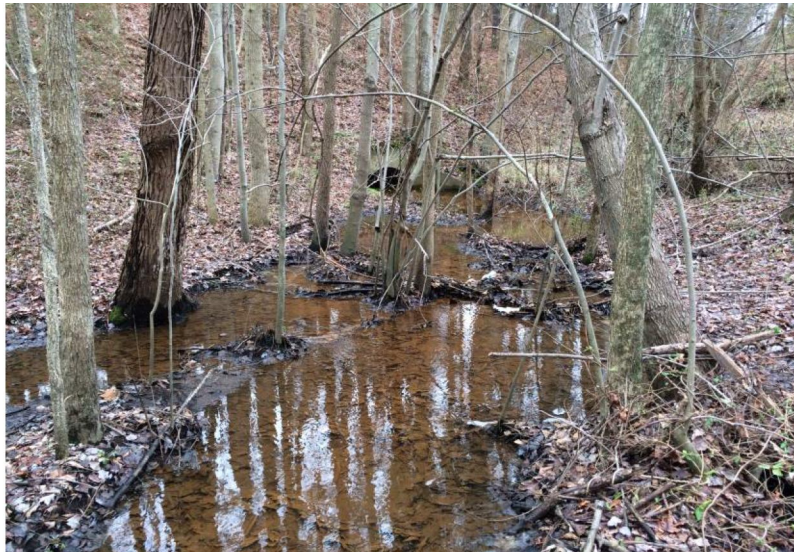
Photo of SAR 11 looking upstream.

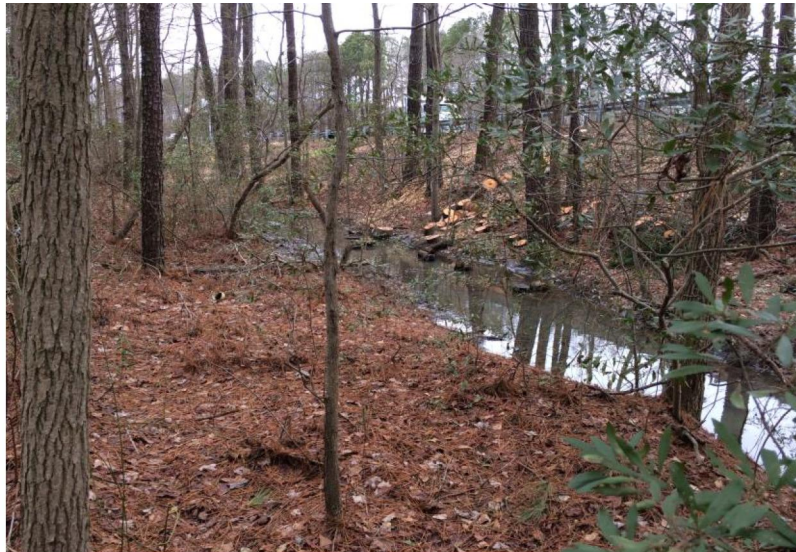
Photo of SAR 12 looking upstream.

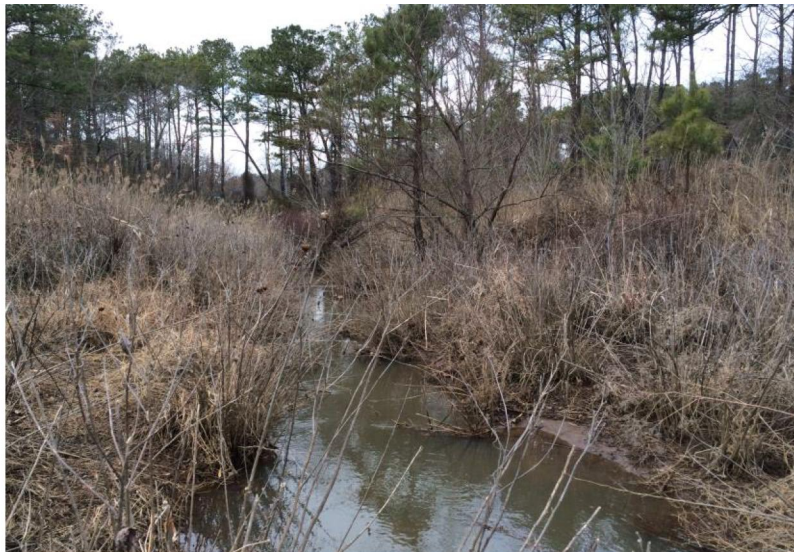
Photo of SAR 13 looking downstream.

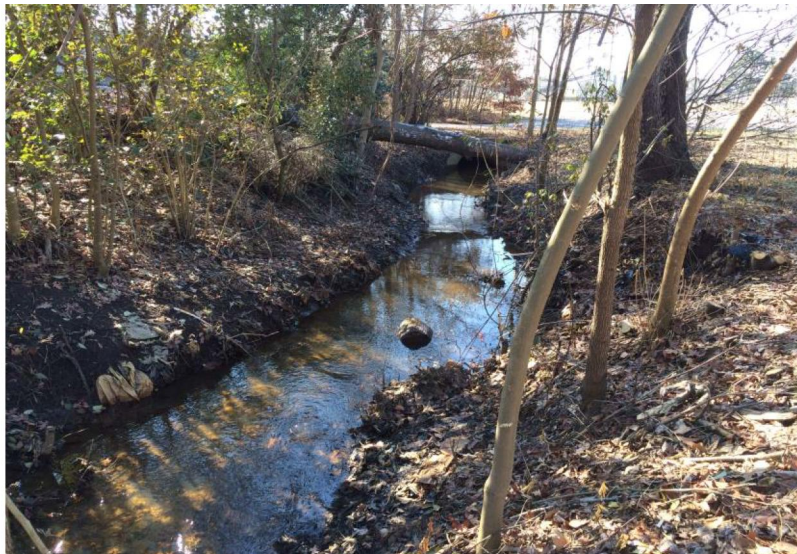
Photo of SAR 14 looking downstream.

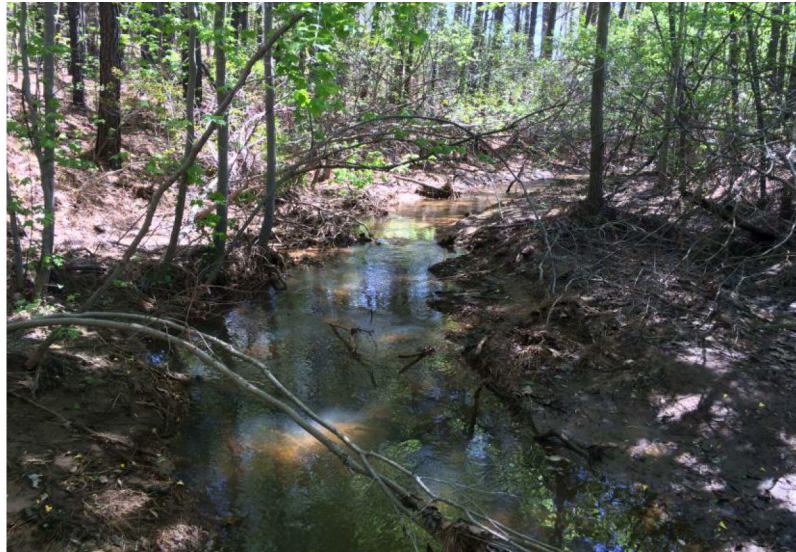
Photo of SAR 15 looking upstream.

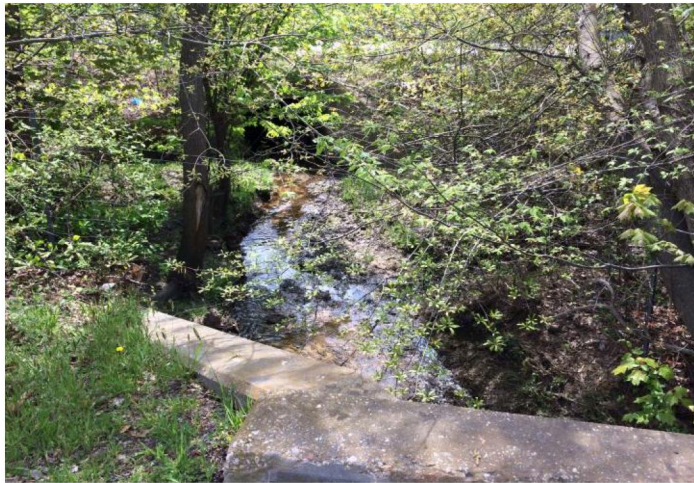
Photo of SAR 16 looking downstream.

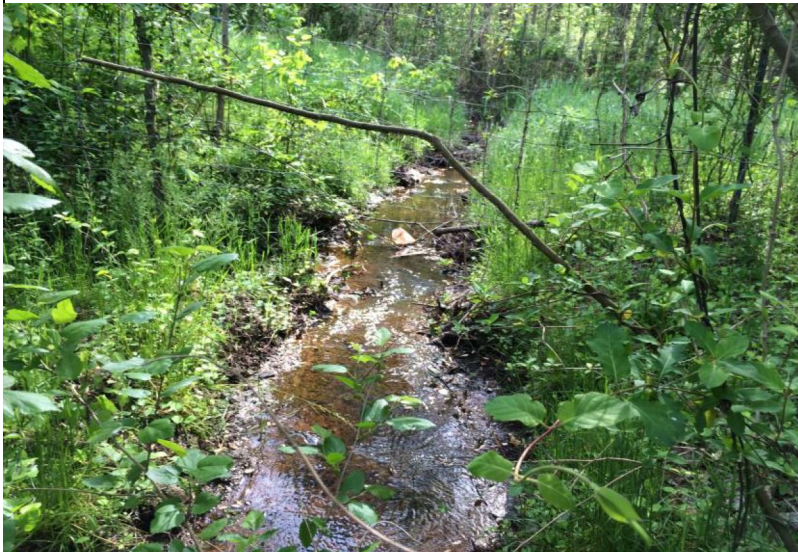
Photo of SAR 17 looking downstream.
